# Engineering Report

Eng 006

**Customer:** GOOD ONE  
**PO No:** 137331  
**Device:** PCB  
**BRF:** 11621  
**QTY:** 1  
**Date:** 06/7/09

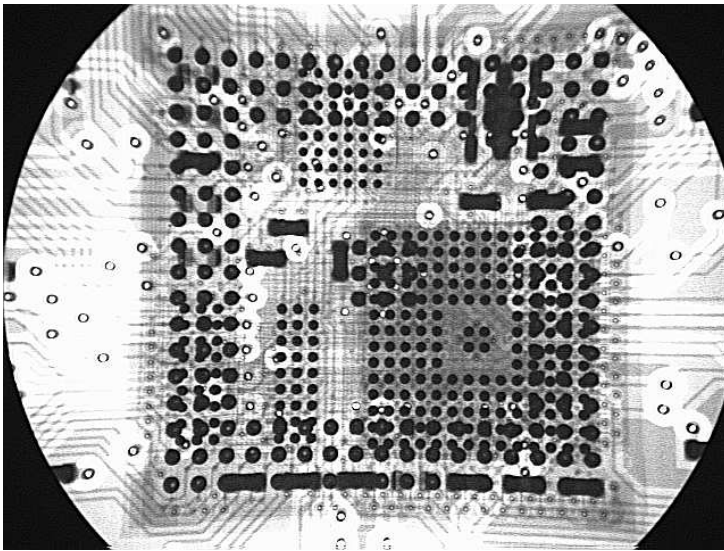
IC1

It was found that IC 1 was a POP. The X-ray image shows that voids are present in the spheres connecting the POP to the PCB. However, they are <25% by area so would not be cause for rejection in line with IPC 610 level 3.

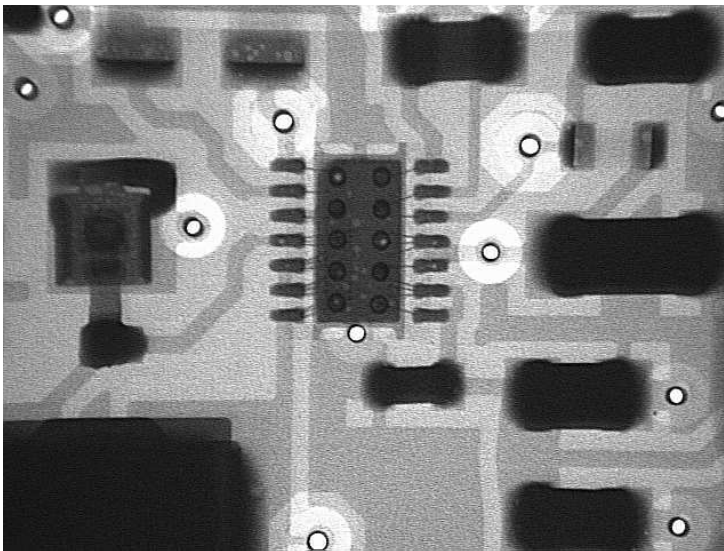
IC24

No further anomalies found on the other devices within the POP. IC24, IC25 and IC29 all Ok.
